LOWER HOUSATONIC RIVER BASIN
WATERBURY , CONNECTICUT

MAD RIVER DAM
CT 00030

PHASE I INSPECTION REPORT
NATIONAL DAM INSPECTION PROGRAM

JANUARY 1980

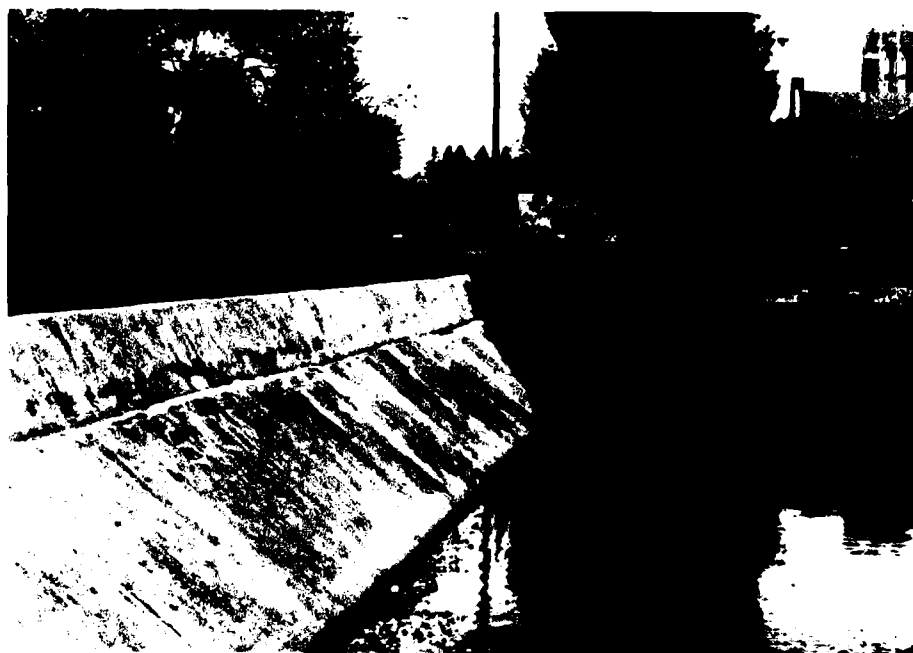
1) Upstream Face - The upstream face appears to be a sloping concrete stone faced masonry wall. A new 3-ft-high concrete parapet wall has been constructed on top of the masonry wall along the right side of the dam from the spillway to the right abutment. On the left side of the spillway, the new concrete parapet wall is approximately 30 feet long and connects to a previously existing stone wall on top of the dam. The parapet wall is in good condition, with only minor spalling observed. Some efflorescence of the concrete was noted along the upstream face. (See photo no. 1 and photo no. 4.)

PHOTO #4: Upstream face of dam looking towards right abutment. Note 3-foot parapet wall on top of concrete face and earth embankment at right side of dam.
